A340 Performance Deterioration

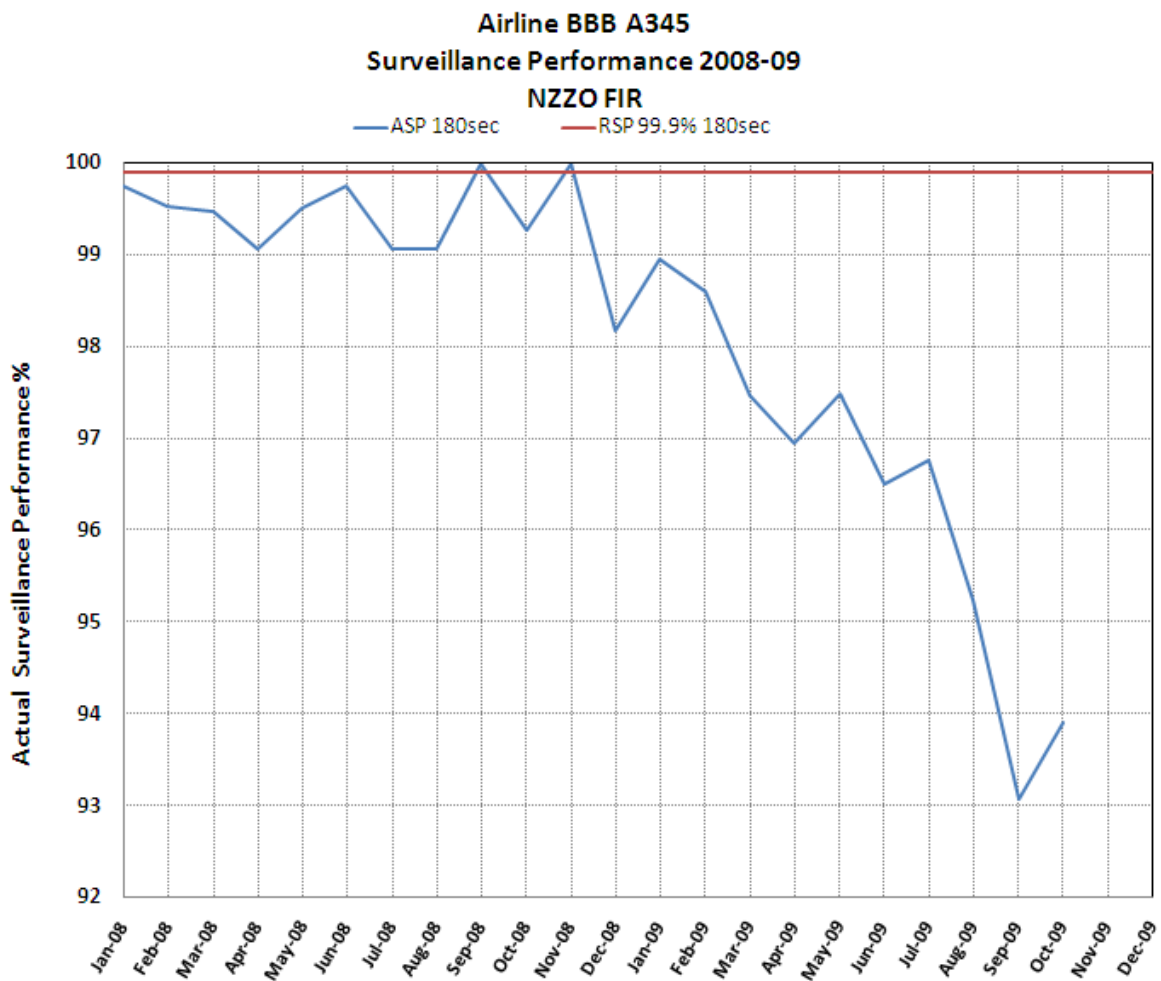
Figure 1 below illustrates the extent of the deterioration by plotting on a monthly basis the actual percentage of ADS-C downlinks delivered within 180secs via SATCOM. This actual surveillance performance (ASP 180) can be compared with the Oceanic SPR required surveillance performance for the application of reduced separations of 99.9% within 180 seconds.

Figure 1: Airline BBB A345 Actual Surveillance Performance (SATCOM)

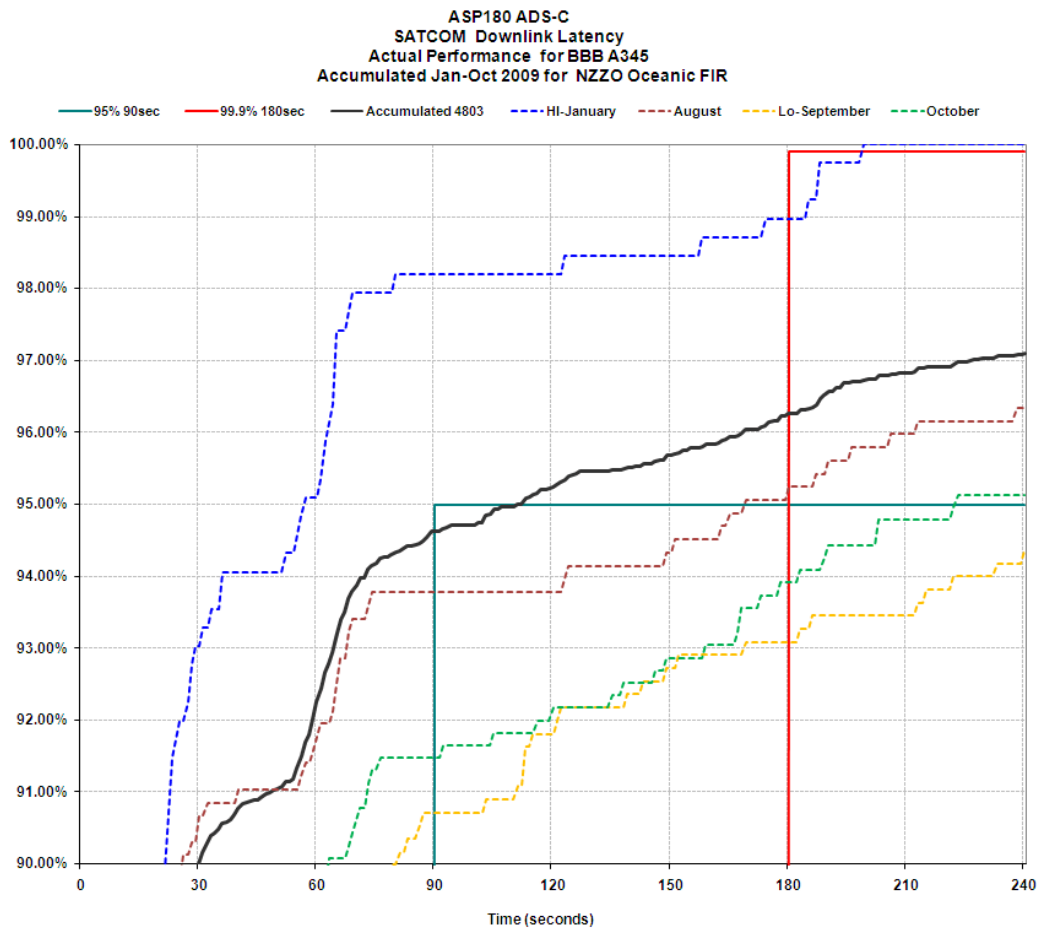
Figure 2 below illustrates the observed ADS-C SATCOM Actual Surveillance performance for the A345 fleet concerned in NZZO during 2009. This graph illustrates typical ANSP monitoring recommended by the Global Operational Data link Manual (GOLD) Appendix D.

Figure 2: Airline BBB A345 Actual Surveillance Performance (SATCOM)

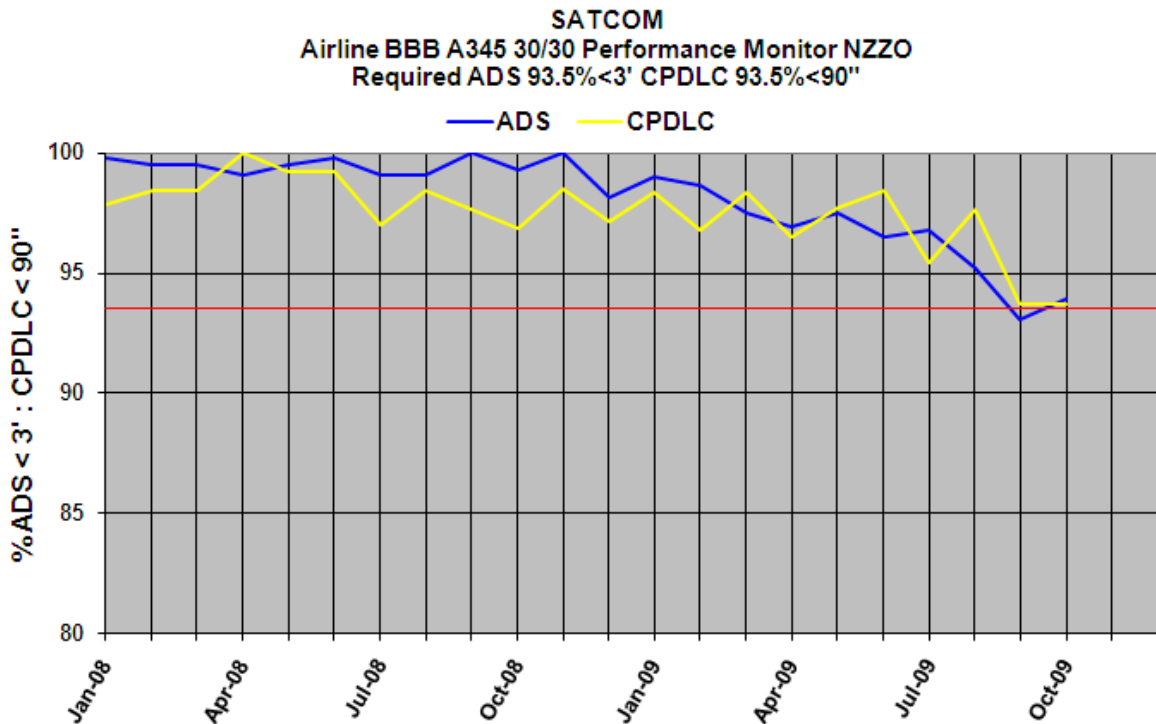
When D30 separations were introduced in 2005 RCP and RSP monitoring as per the Oceanic SPR standard had not been developed. In 2005 GES stability issues were causing concern and the ISPACG implementation team determined that the required safety levels for the application of D30 would be maintained if 93.5% of ADS downlinks were received within 3 minutes, and 93.5% of CPDLC downlinks were received within 90 seconds. The performance of the A345 fleet using these requirements is illustrated in Figure 3.

Figure 3: Airline BBB A345 30-30 Separation Performance Monitor

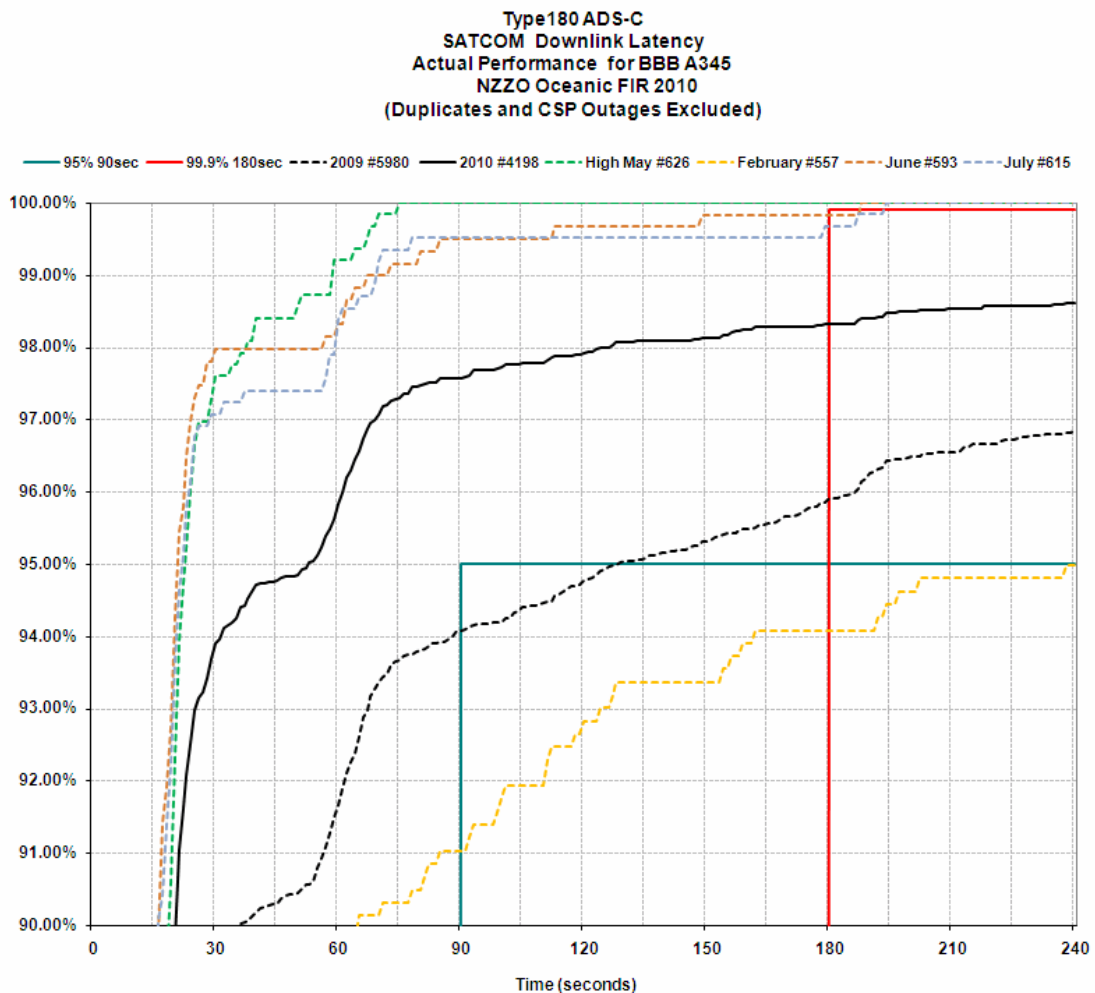
Update 9 August 2010. Release 15 has now been installed at both SITA and ARINC's I3 GES sites. Observed performance of the A345 fleet since the Release 15 upgrade is illustrated below in Figure 4. Performance is now meeting SPR requirements, and the graph illustrates degraded performance in February (pre R15) and significantly improved performance in May, June, and July (Post R15). The application of 30/30 separation has been restored on this fleet.

Figure 4: Airline BBB A345 30-30 Actual Surveillance Performance after R15
