During the development of ADS latency monitoring in 2008 it was noted that the performance of the B777 fleets were considerably below what was expected. An assessment of all delayed reports greater than 90 seconds demonstrated that there was a significant correlation between the downlink delays and areas of transition from VHF to SATCOM RGS for B777 aircraft. This correlation did not exist for B744 or A340 aircraft. The performance of B777 and A340 aircraft when the delays due to B777 RGS transition are excluded are similar. The following figures demonstrate the analysis.

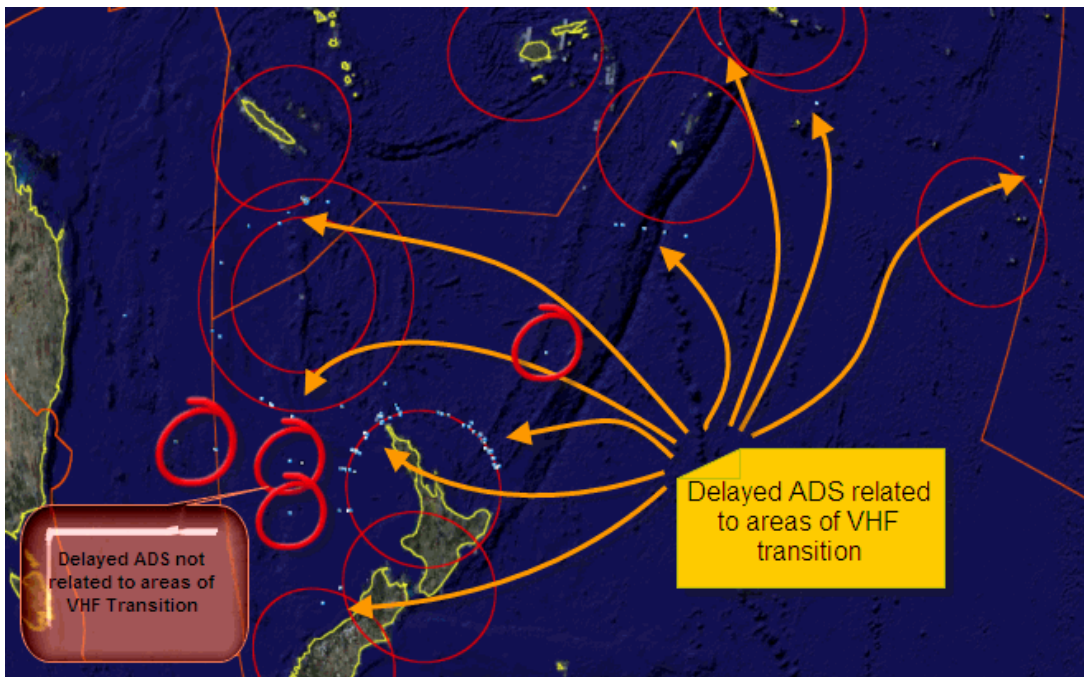
Figure 1. Geographic plot of B777 delayed ADS reports and VHF transition areas

Boeing have investigated this problem report and identified an issue with the B777 when transitioning from SITA VGS into SATCOM. A fix has been made and will be released to the B777 fleets when the AIMS BP14 upgrade becomes available from the end of 2009.

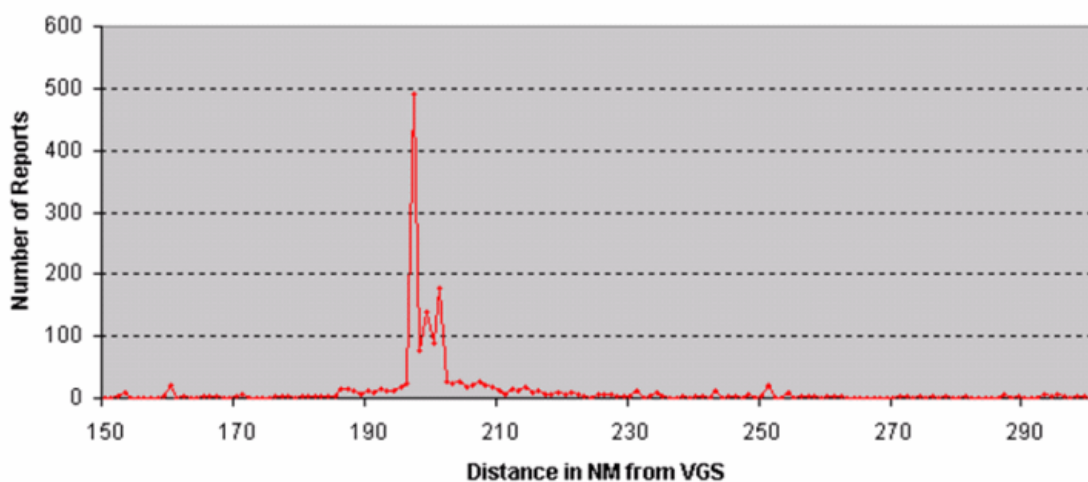
Figure 2. Plot of B777 delayed reports against distance from nearest VHF ground station.

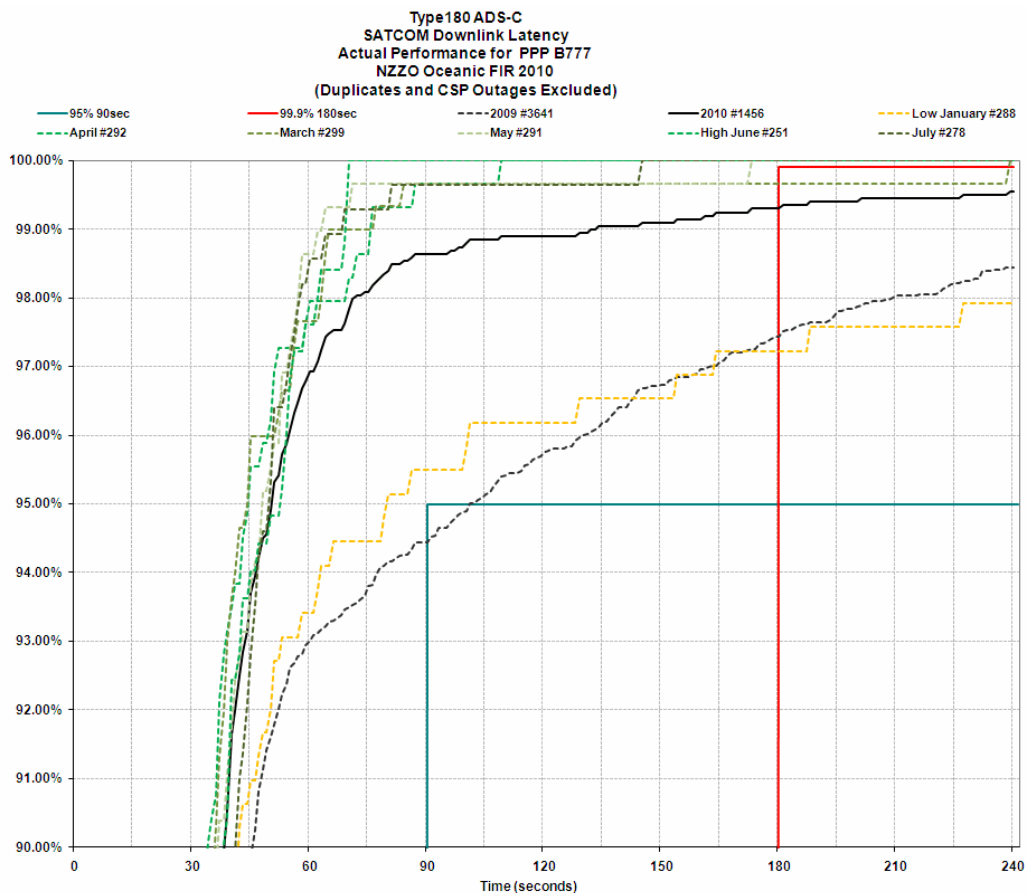
Update 9 August 2010. The BP14 upgrade for AIMS-2 aircraft became available 1st quarter 2010. In NZZO we have seen two fleets implement the BP14 and significant performance improvements have been observed. Figure 5 below illustrates the performance improvement seen on the fleets that have installed BP14. This fleet completed the BP14 upgrade in March 2010. The fleet is now consistently meeting the SPR requirements and the performance improvement is clearly visible between February (pre-BP14) and other months (post BP-14).

Figure 5. B777 latency POST BP14 upgrade.

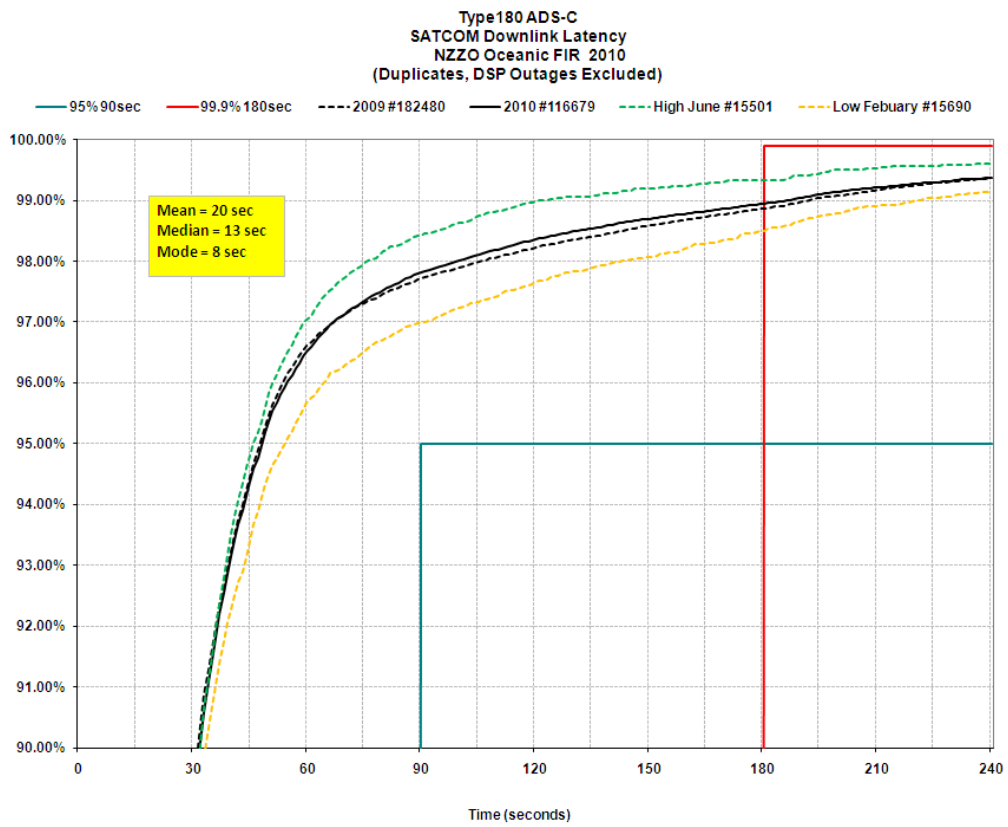
An assessment of current performance with that seen earlier in 2010 before BP14 was installed on two fleets operating in NZZO and the R15 GES upgrade was installed shows that significant performance improvement has been made. This is illustrated in Figure 6.

Figure 6. SATCOM latency PRE/POST BP14 R15 GESupgrade.
